Re: Status of Coastal Structure Repair Work along Triton Way

Project Overview and Scope

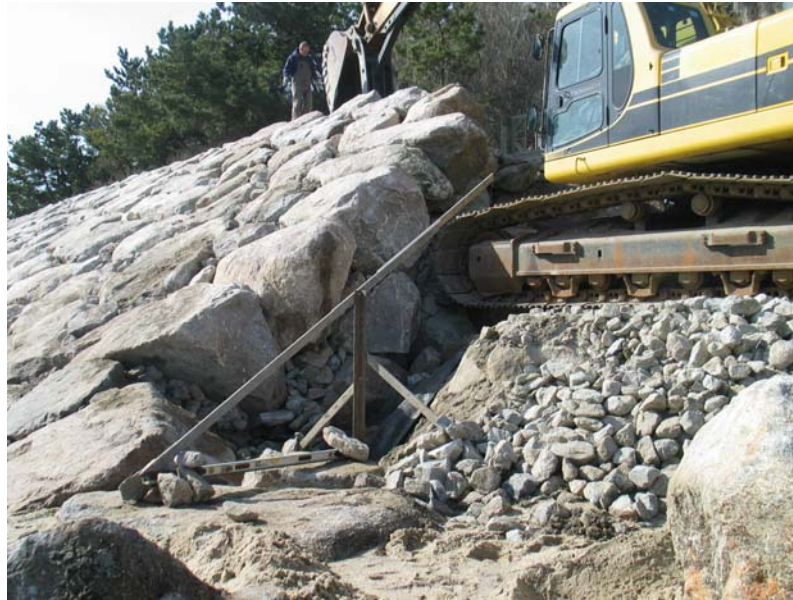
Figure 1. Representative photograph of the reconstructed revetment.

A basic overview of the project is as follows. Existing coastal structures along Succonesset Point have suffered damage over the past several years. The cause of the damage is continued exposure to storm waves and elevated water levels, combined with ongoing beach erosion. Many of the structures were not designed originally to withstand direct and constant wave attack; therefore, damage occurred when design conditions were exceeded. As a result

of the damage, there is a need to increase the level of protection provided by these structures to ensure adequate protection to the upland properties. The improvements include increasing the size and thickness of the armor units, and increasing the height of the existing structures. An improved design was developed, and permits were obtained from regulatory authorities to perform the work. A highly qualified contractor with impeccable references also was selected to perform the work (CF Briggs out of Marion, MA).

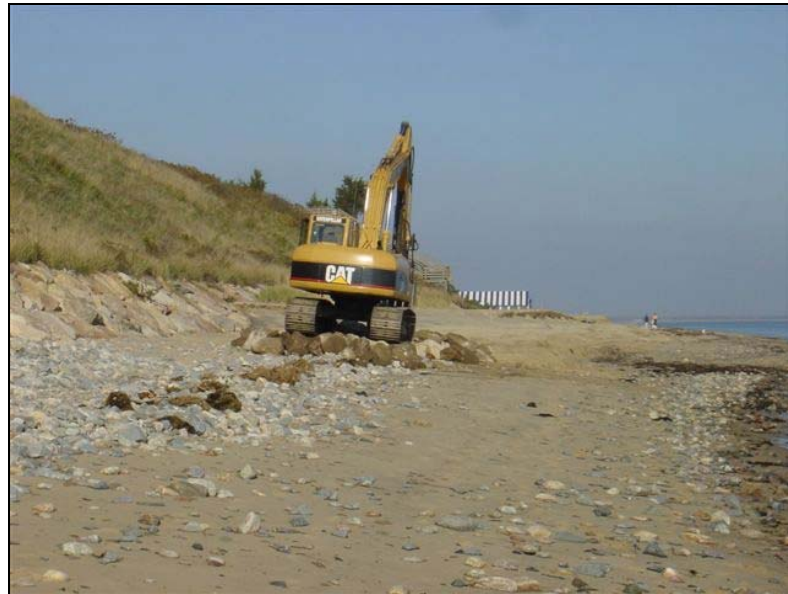
Figure 2. Photograph of the southern portion of the Maushop Village Beach taken the day the access way installation commenced.

While the access way is being removed, Woods Hole Group will be observing and monitoring the condition of the beach to ensure it is restored to pre-construction or better condition. Woods Hole Group has also requested that representatives from each of the regulatory agencies be on site regularly during the clean up to ensure that the method is acceptable and the end result is one that they are satisfied with. Figure 2 taken on November 8, 2006 is a representative photograph of the southern portion of the Maushop Village beach at the start of the project. This photograph was taken the day the access way construction began. Figure 3 was taken on November 30, 2006 and shows the condition of the beach before the access way was installed in front of 10 and 16 Triton Way, just north of the project site. To ensure a fair and balanced opinion is offered regarding the restoration of the beach, a consultant for Maushop Village will be inspecting the beach as well. Together, the two groups, in cooperation with the regulatory authorities, will agree upon satisfactory removal of the access way and restoration of the beach. The access way is scheduled to be removed by April 30.

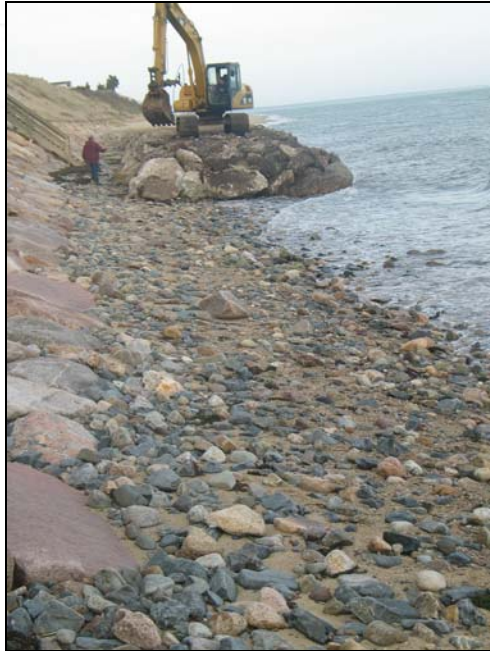
Figure 3. Photograph of the beach fronting 10 and 16 Triton Way during the access way installation.
